36th International SAMPE Symposium April 15-18, 1991

RELATIONSHIP OF GRAPHITE/POLYIMIDE COMPOSITES TO GALVANIC PROCESSES

Michael C. Faudree Composite Materials and Process Engineering General Dynamics Fort Worth Division Fort Worth, Texas 76101

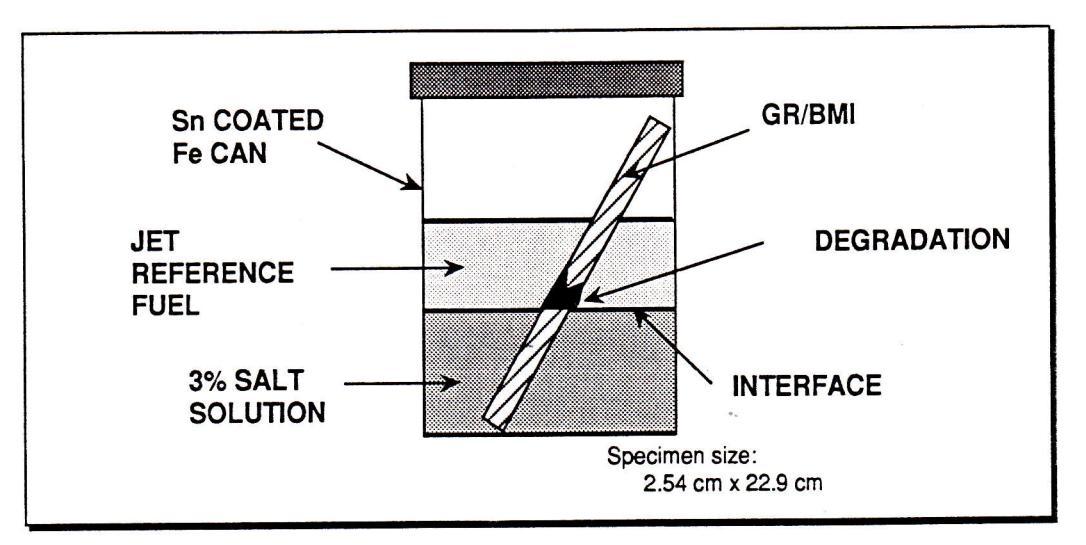
Figure 1 illustrates the setup in which BASF's IM7/5250-4 graphite/BMI coupons were placed in physical contact with the tin can in a jet fuel/salt water solution. UV Fluorescence showed the tin can to be tin (Sn) coated iron (Fe). Composite coupons used were 2.54 cm by 22.9 cm. The tape layup used was $(\pm 45)_{2S}$. This experiment was originally part of a test matrix to evaluate candidate aircraft material's resistance to various aircraft fluids. One of the fluids was fuel-tank sump water, a 50-50 (by volume) mixture of Jet Reference Fluid (JRF, TTS-735 Type VII), which

Figure 1 Setup Showing the GR/BMI-Tin Can Experiment

In this work, the above setup will be referred to as JRF/3% salt water/Fe-Sn can. Here, the organic and aqueous phases were immiscible and formed an interface (Figure 1) referred to here as the organic/aqueous interface.

Composite degradation was found to occur in bare IM7/5250-4 composite after one day exposure in the tightly sealed JRF/3% salt water/Fe-Sn can (Figure 1) and 3% salt water/stagnant air/Fe–Sn can environments. Degradation was in the form of resin breakdown of the outer plies just above the organic/aqueous interface. Location of the degradation zone was above the salt water phase. Degradation occurred wherever bare graphite was exposed just above the organic/aqueous interface. For the above tests, degradation occurred within one day at 25° C and 80° C. However, the degradation rate appeared to be much slower at the ambient temperature (25° C).

Included are high-crosslink density triazine and IM6/K-III (Avimid-K). Specimens degraded independent of ply orientation or thickness or if graphite fabric was used instead of tape. In all cases, degradation appeared in the region illustrated in Figure 1.

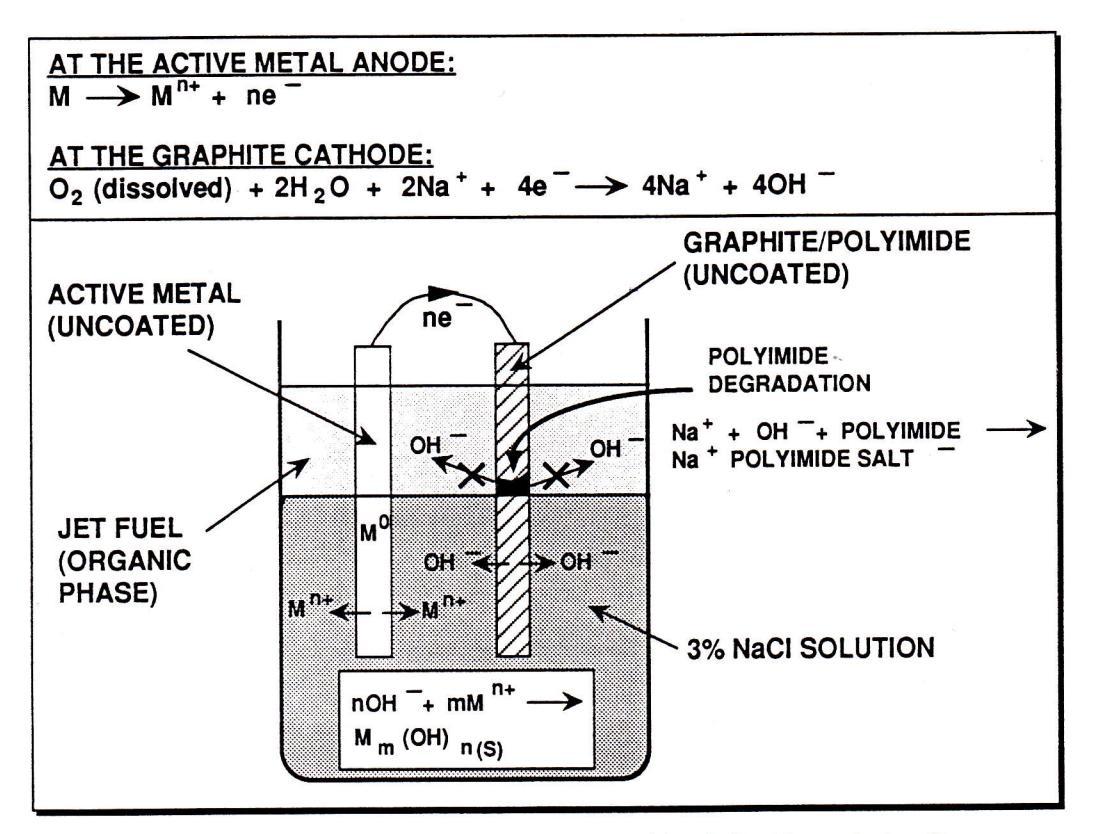
Figure 2 illustrates a schematic of the polyimide degradation galvanic process mechanism. Anode and cathode half reactions are listed at the top of the figure. The metal of the anode is designated 'M' to symbolize any active metal in relation to graphite. At the metal anode, metal ions go into solution sending electrons to the graphite cathode.

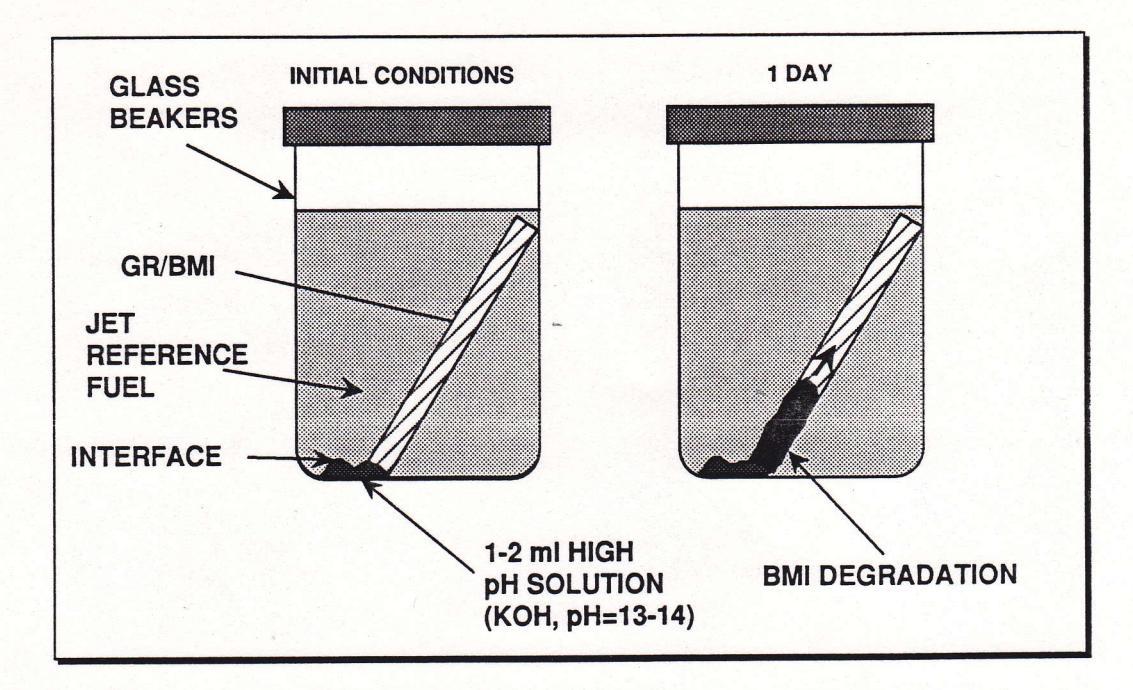
An experiment was conducted to show that water can travel up the composite surface into the organic phase, allowing polyimide degradation. Surface tension may be a driving parameter for the water travel. Figure 3 illustrates the setup, in which a very small amount, 1 to 2 ml of high pH KOH solution, was mixed with JRF in a glass beaker. The pH of the aqueous phase was measured to be 13 to 14. The aqueous phase separated from the organic phase and settled at the bottom of the beaker. The bare IM7/5250-4 was placed into the solution with the end in contact with the aqueous phase. No active metal was added, hence no galvanic cell existed.

Figure 3 Schematic of Experiment Which Proved Water Travels Up the Composite Surface Into the Jet Fuel Phase Allowing Ployimide Degradation

After one day, the high pH solution travelled up the composite surface into the organic phase. This was evident by severe degradation in the outer 1-2 plies of the coupon in the JRF phase. The degradation extended from the pool of high pH water at the bottom of the coupon. The darkened portion of the coupon shown in Figure 3 shows the degradation location. The film's travel distance above the aqueous phase is finite and limited to 3 to 5 cm above the aqueous/fuel interface.

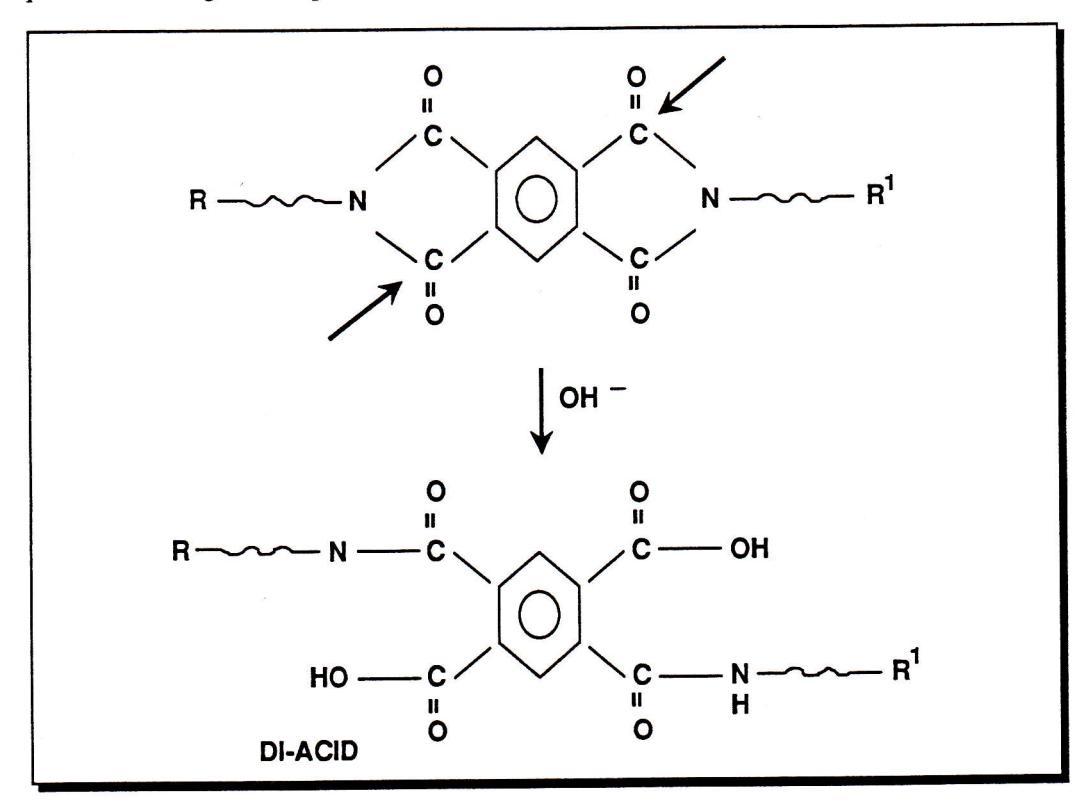
Polyimides used in graphite composites have the same imide ring illustrated in Figure 4. Degradation products were a brown gummy substance. FTIR results have shown N-H groups present in the degradation products. However, broad bands covering nearly the entire spectrum

Figure 4 Mechanism of Hydroxyl Attack on Simple Polyimide Ring Structure

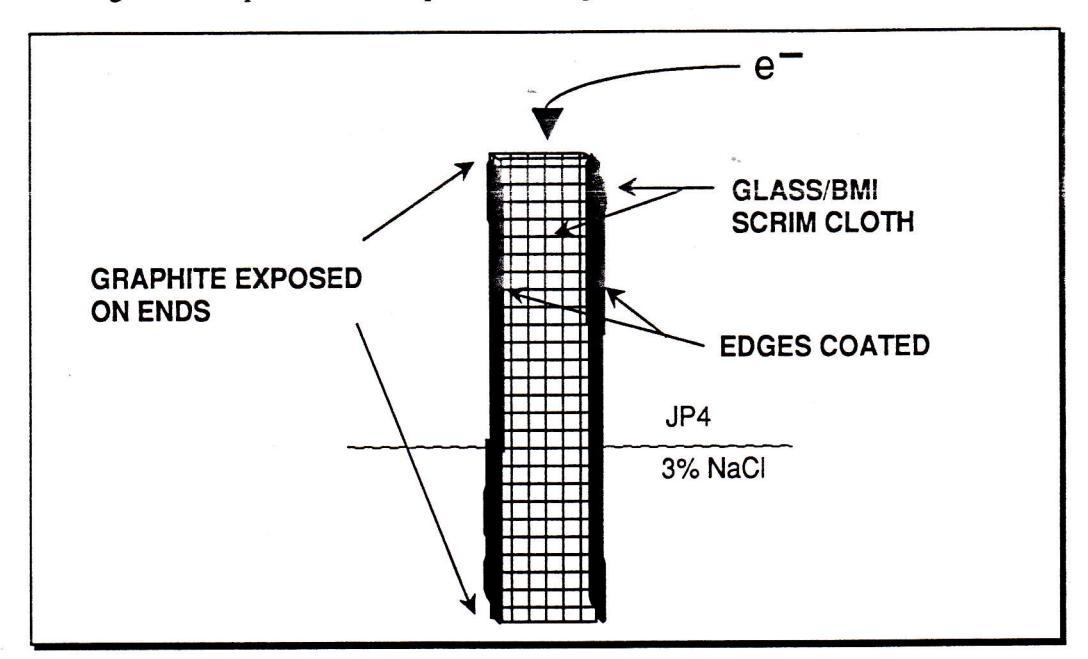
Figure 5 illustrates the specimen design in which 26 ply IM7/5250-4 specimens were used. The specimen had 120 glass/BMI scrim on both faces. The free specimen edges were protected with polysulfide sealant to prevent the graphite from being exposed to the salt water. No graphite was exposed at the interface. Both specimen ends were sanded to allow electrical connection with the active metal of the Fe-Sn can. The coupons survived two months in this harsh environment, showing that scrim protects the composite from degradation.

Figure 5 Glass/BMI Scrim Protected the Composite in the Galvanic Environment. Graphite Was Exposed at Specimen Ends Allowing Contact with the Active Metal of the Fe/Sn Can.

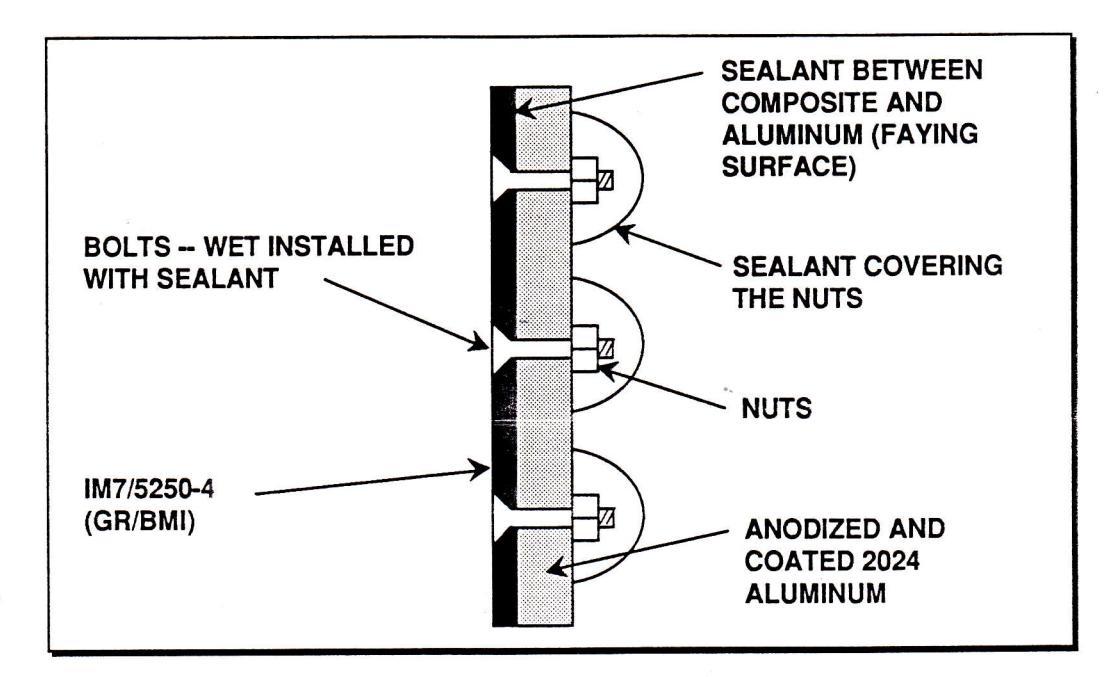
Figure 6 Composite/Aluminum Coupled Specimens. Polyimide Degradaton Was Not Observed in These Specimens for 3000 Hours in the Salt-Fog (22) Environment.

All graphite/polyimides in salt fog (22)/draining condition were undamaged after 3000 hours exposure when coupled to coated aluminum. This includes specimens with bare composite.

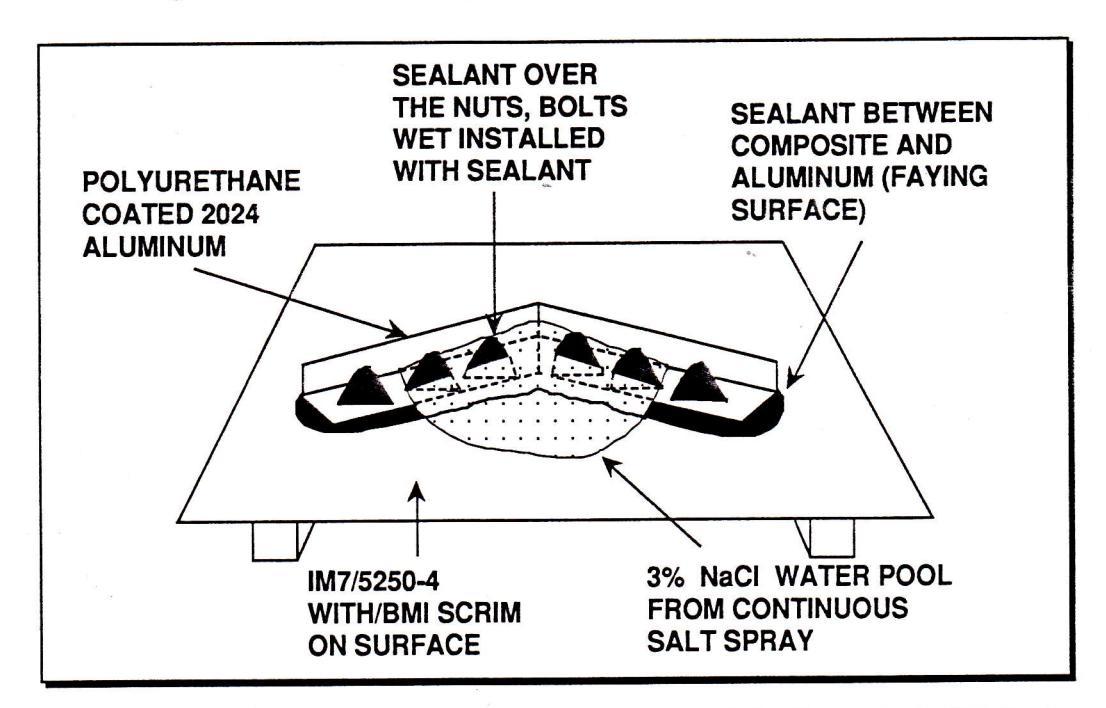
Figure 7 illustrates an experiment in which normal protection prevented BMI degradation in pooling situations in salt fog. The situation is similar to that occurring on aircraft. Figure 7 illustrates the setup in which coated 2024 aluminum L-angle spars were bolted to an IM7/5250-4 panel. The panel was fabricated with 120 glass/BMI scrim on both surfaces. Aluminum was chromate anodized and coated with polyurethane coating (5,6) prior to drilling. As in the previous set of experiments, titanium bolts and cress steel nuts were used to bolt the aluminum in a "V" configuration to permit water pooling (Figure 7). Polysulfide sealant (5,6) was applied to areas as shown in the figure and in bolt holes immediately prior to assembly. The panel was placed in a salt-fog chamber at approximately 20 degrees from the horizontal. During the experiment, water was continuously replenished at the pooling area from the continuous salt spray.

Figure 7 Standard Aircraft Protection Schemes Protected the Composite in Salt Fog/ Pooling Environment.

After 1000 hours in the salt-fog, neither composite nor aluminum showed corrosion. A salt deposit but no aluminum pitting was present at the base of the "V." The glass scrim prevented salt water from contacting the graphite, therefore breaking the electrical circuit.
